Environmental Projects: Volume 12

Friable Asbestos Abatement, GDSCC

Goldstone Deep Space Communications Complex

The present report, which describes the friable asbestos-abatement program at the GDSCC, consists of the text, illustrations, and tables that describe the friable asbestos abatement carried out at the GDSCC from December 21, 1988, to its end on May 11, 1989. All records and archival material pertinent to the implementation of the friable asbestos-abatement program can be found in Friable Asbestos Abatement Supplemental Records, JPL D-7450 (internal document), Jet Propulsion Laboratory, Pasadena, California.

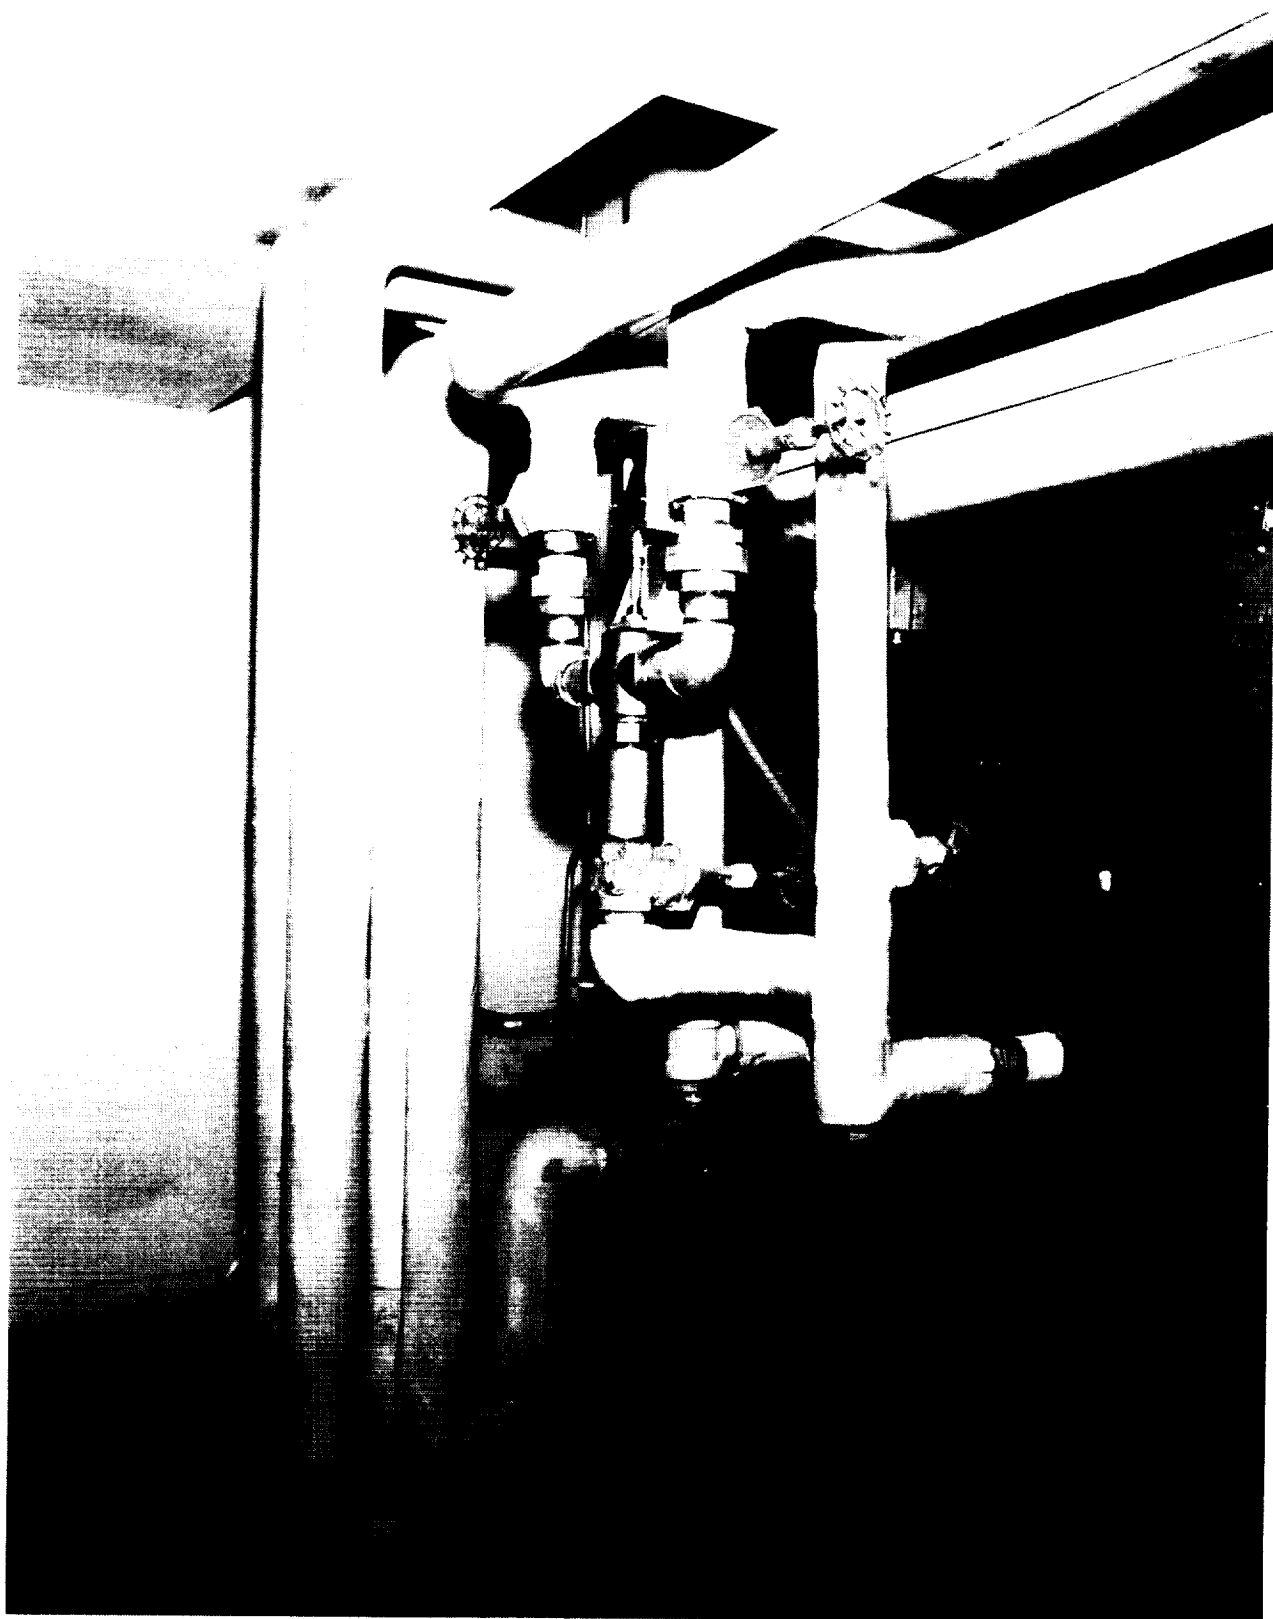
Figure 9 depicts the friable asbestos-containing pipe-lagging in Room 127 of Building G-21 BEFORE the asbestos-abatement program, while Figure 10 shows the re-insulated pipes AFTER the friable asbestos pipe lagging was removed.

Figure 9. Echo Site: Building G-21. BEFORE Asbestos Removal.
Mechanical Equipment Room 127 With Pipe Lagging
Containing Friable Asbestos.

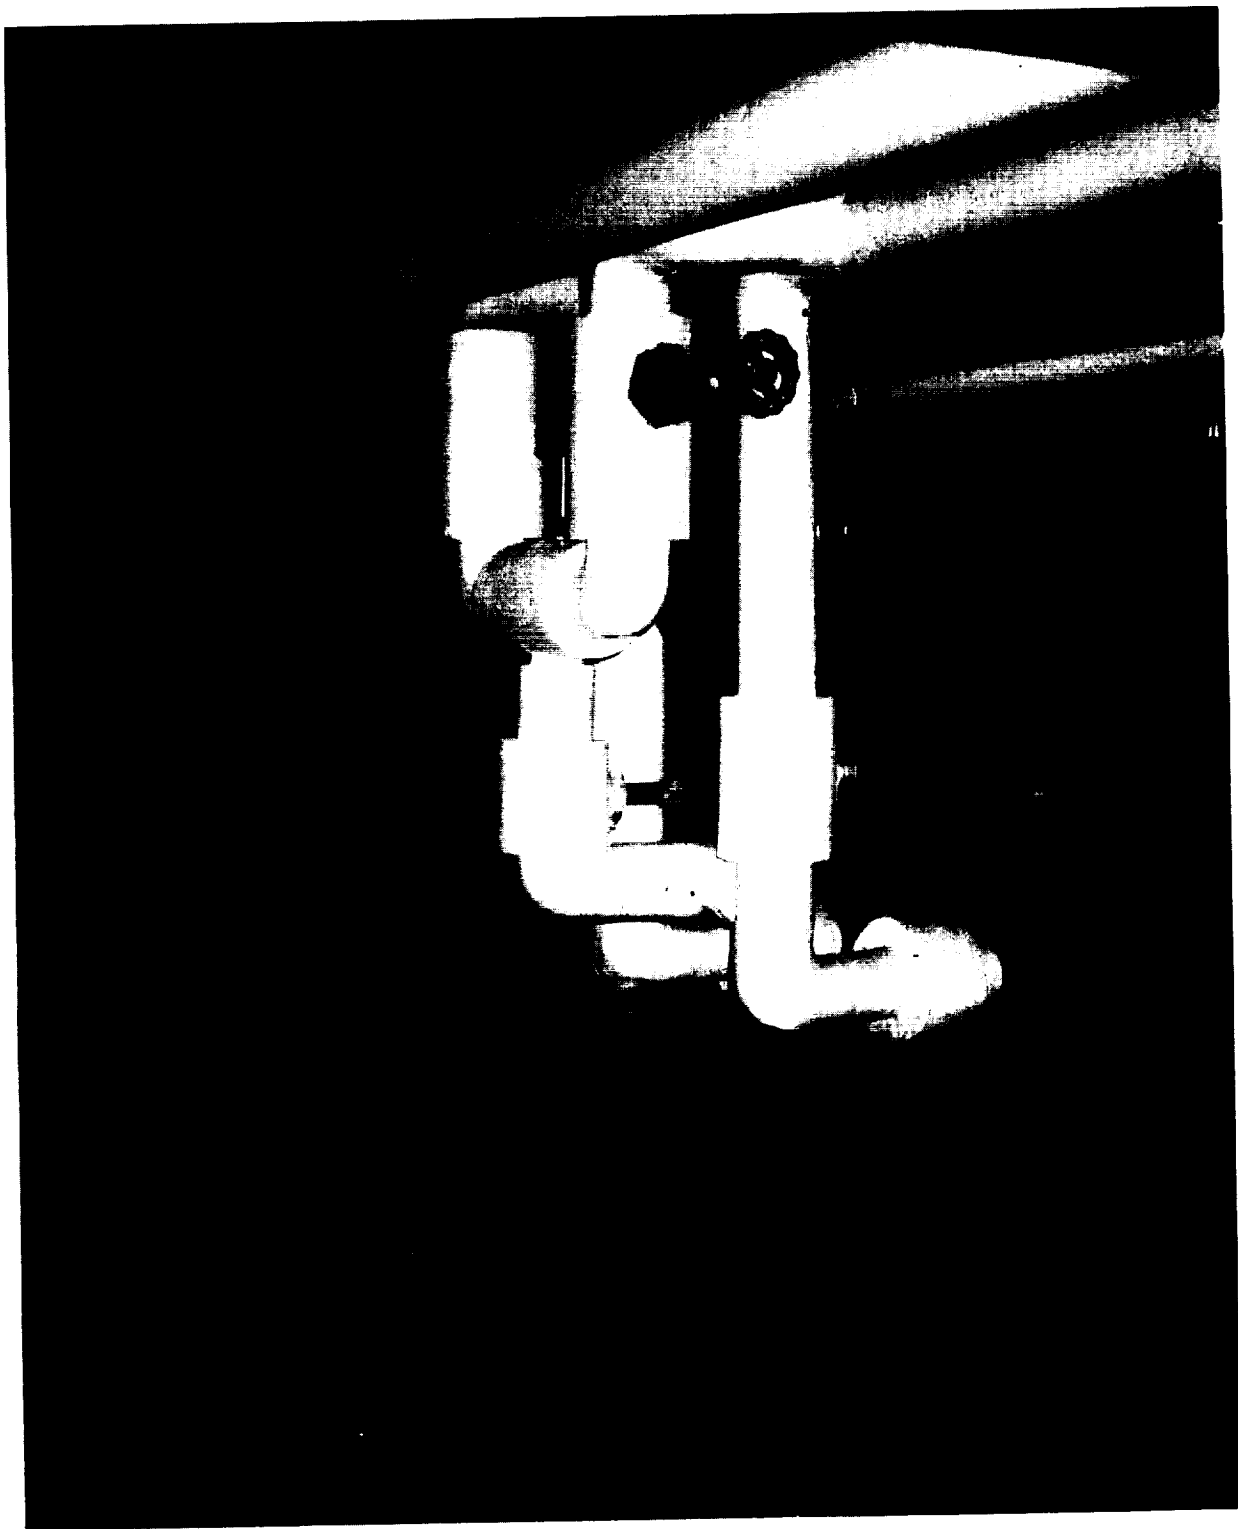
Figure 10. Echo Site: Building G-21. AFTER Asbestos-Removal. Mechanical Equipment Room 127 With Friable Asbestos. Pipe Lagging Removed and Replaced With Armaflex and Fiberglass Insulation.

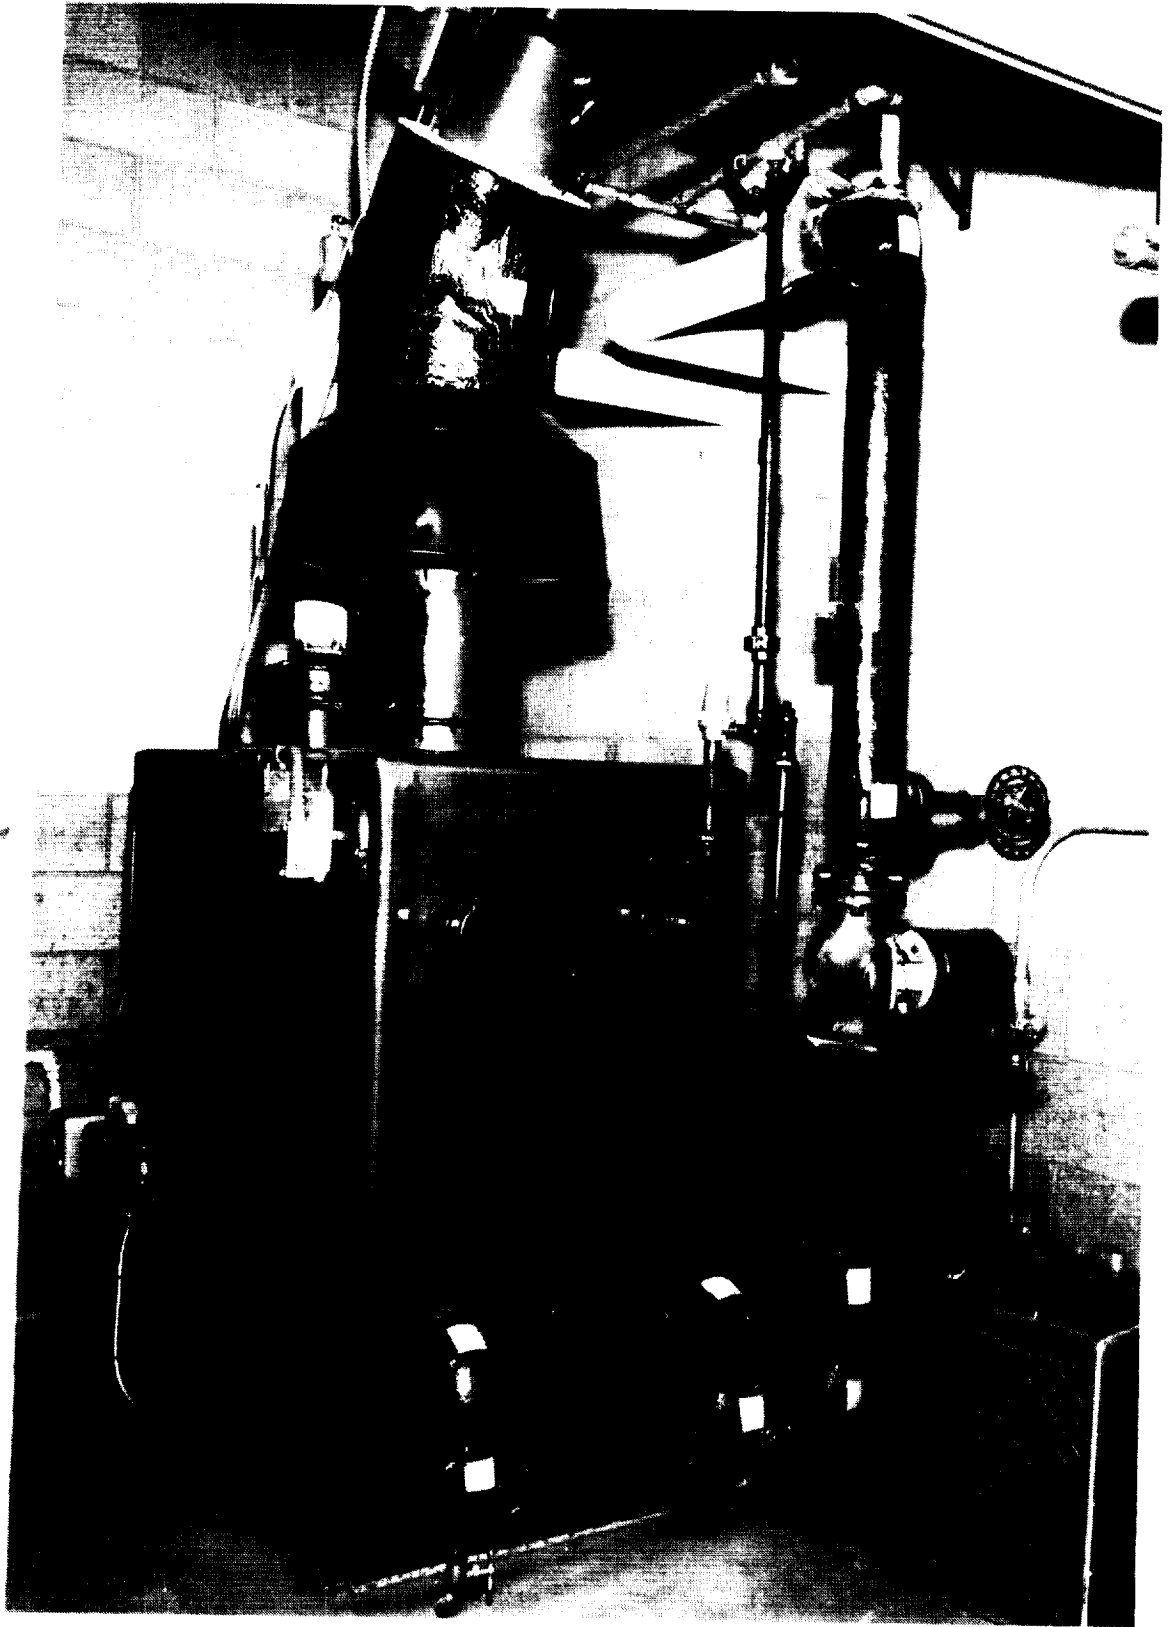
Figure 11. Echo Site: Building G-21, Boiler Room 128 Showing Typical Pipe Lagging Containing Friable Asbestos.

A Bryan Model 313 W Boiler is located in Room 128 (Figure 11). Approximately 100 linear feet of fiberglass insulation on the piping associated with the boiler was replaced along with the friable asbestos insulation that covered the pipe fittings and boiler exhaust flue. Of course, heating and mechanical equipment were shut down during the asbestos-abatement work.

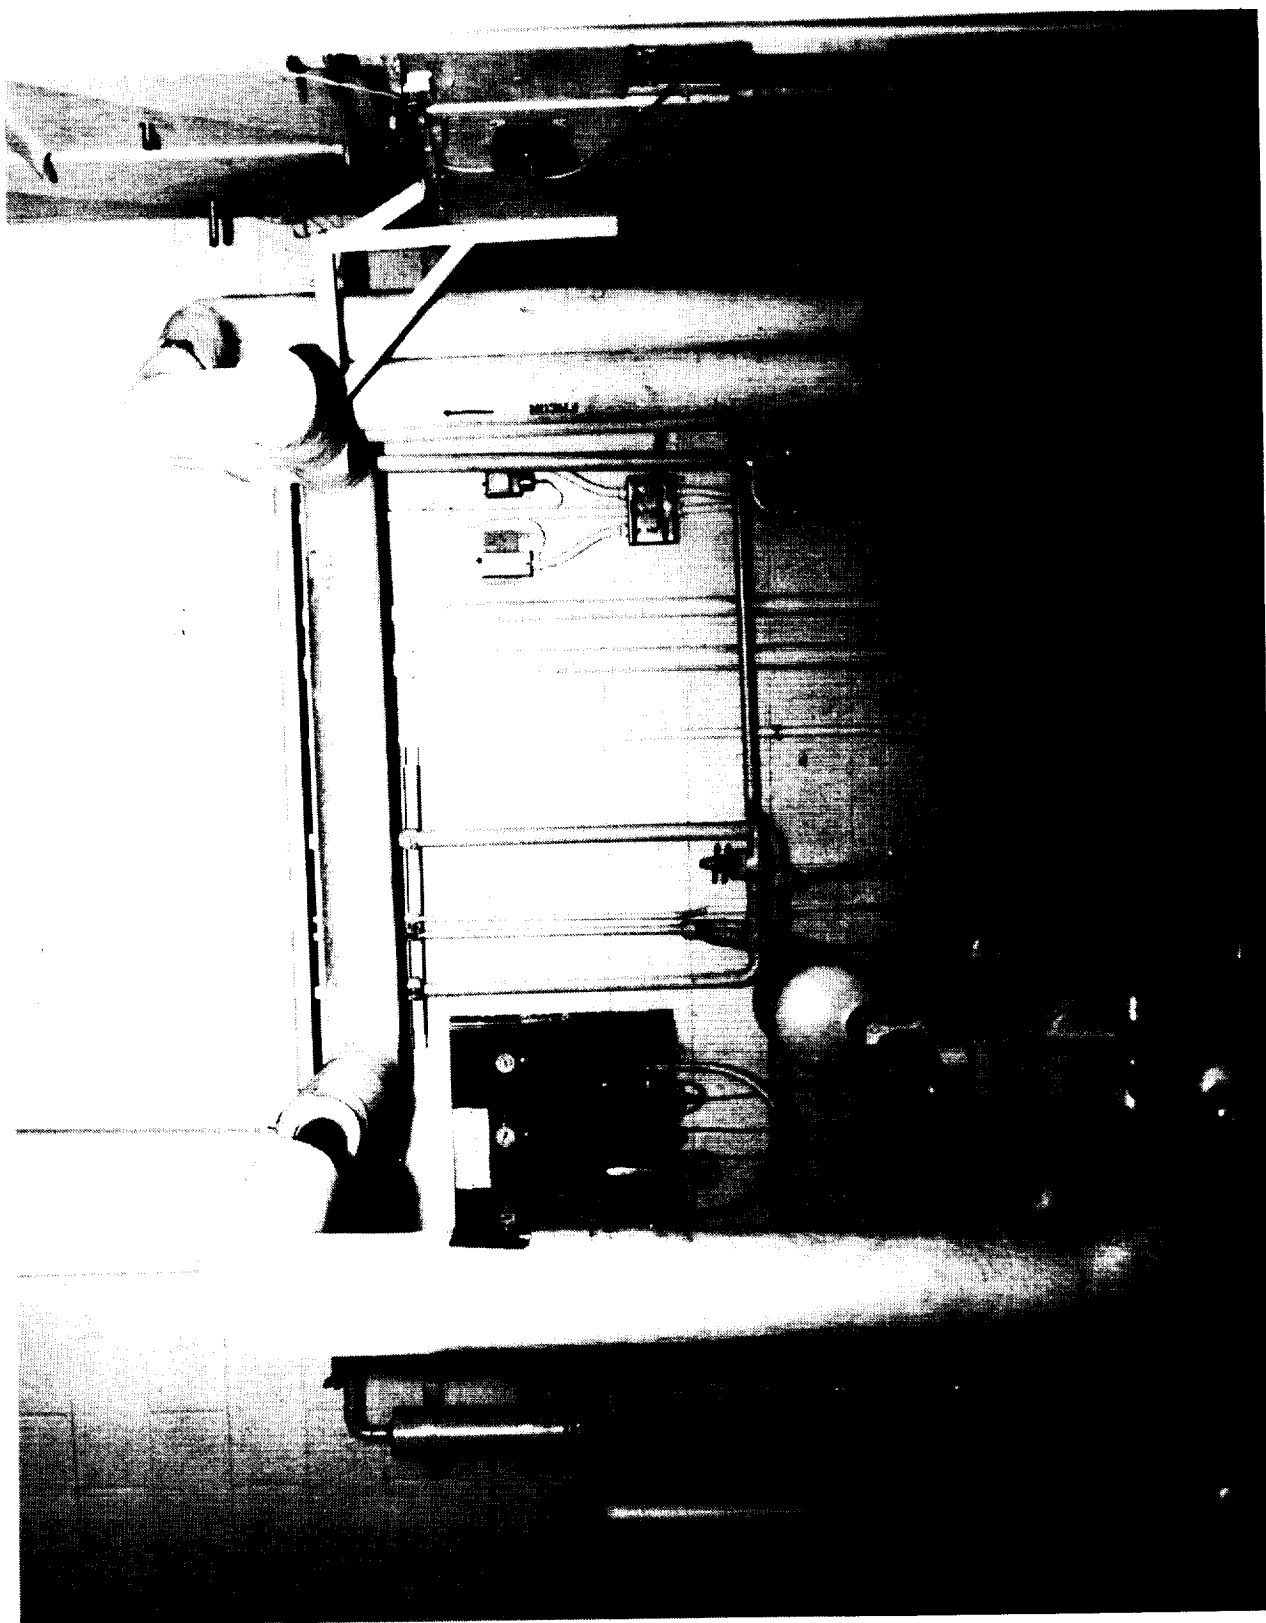
Figure 16. Echo Site: Building G-33. BEFORE Asbestos Removal. Mechanical Equipment Room 141 With Pipe Lagging Containing Friable Asbestos.

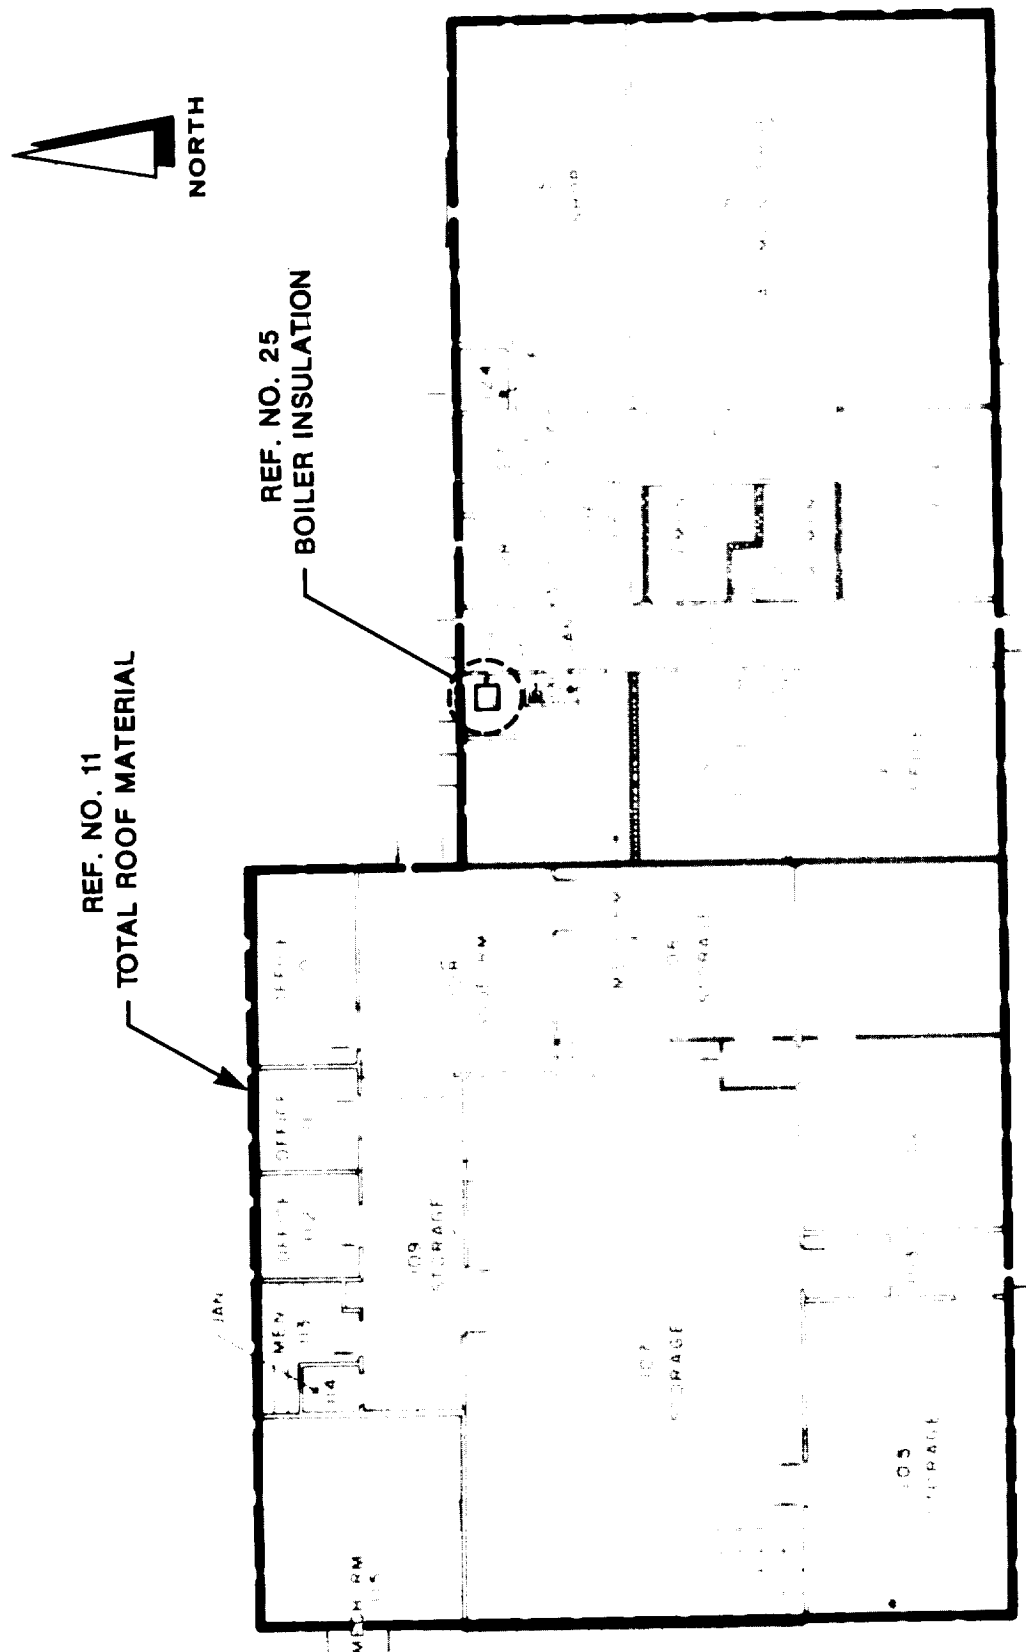
Comments: ROOF MATERIAL COVERING OF TAR ON CONCRETE. SEE FIGURE 19.

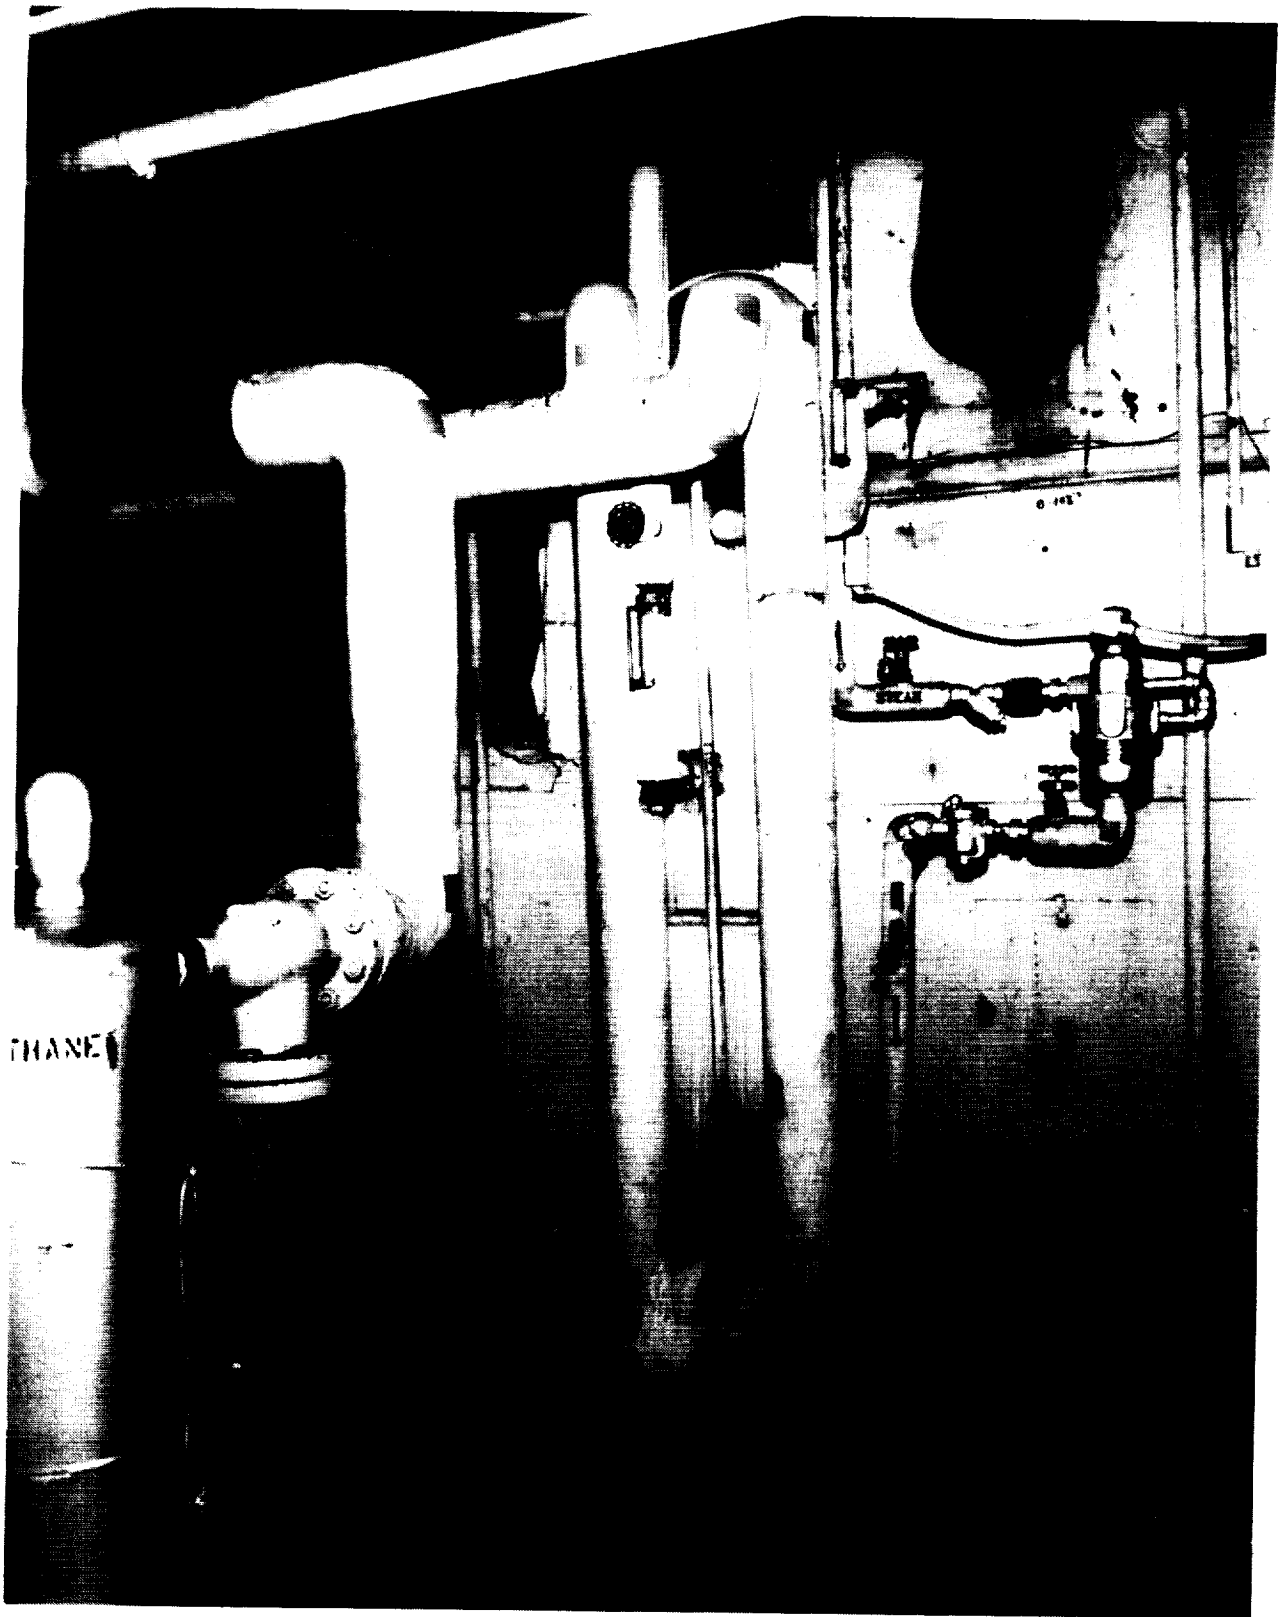
Figure 20. Echo Site: Building G-38. BEFORE Asbestos Removal.
Mechanical Equipment Room 115 With Pipe Lagging
Containing Friable Asbestos.

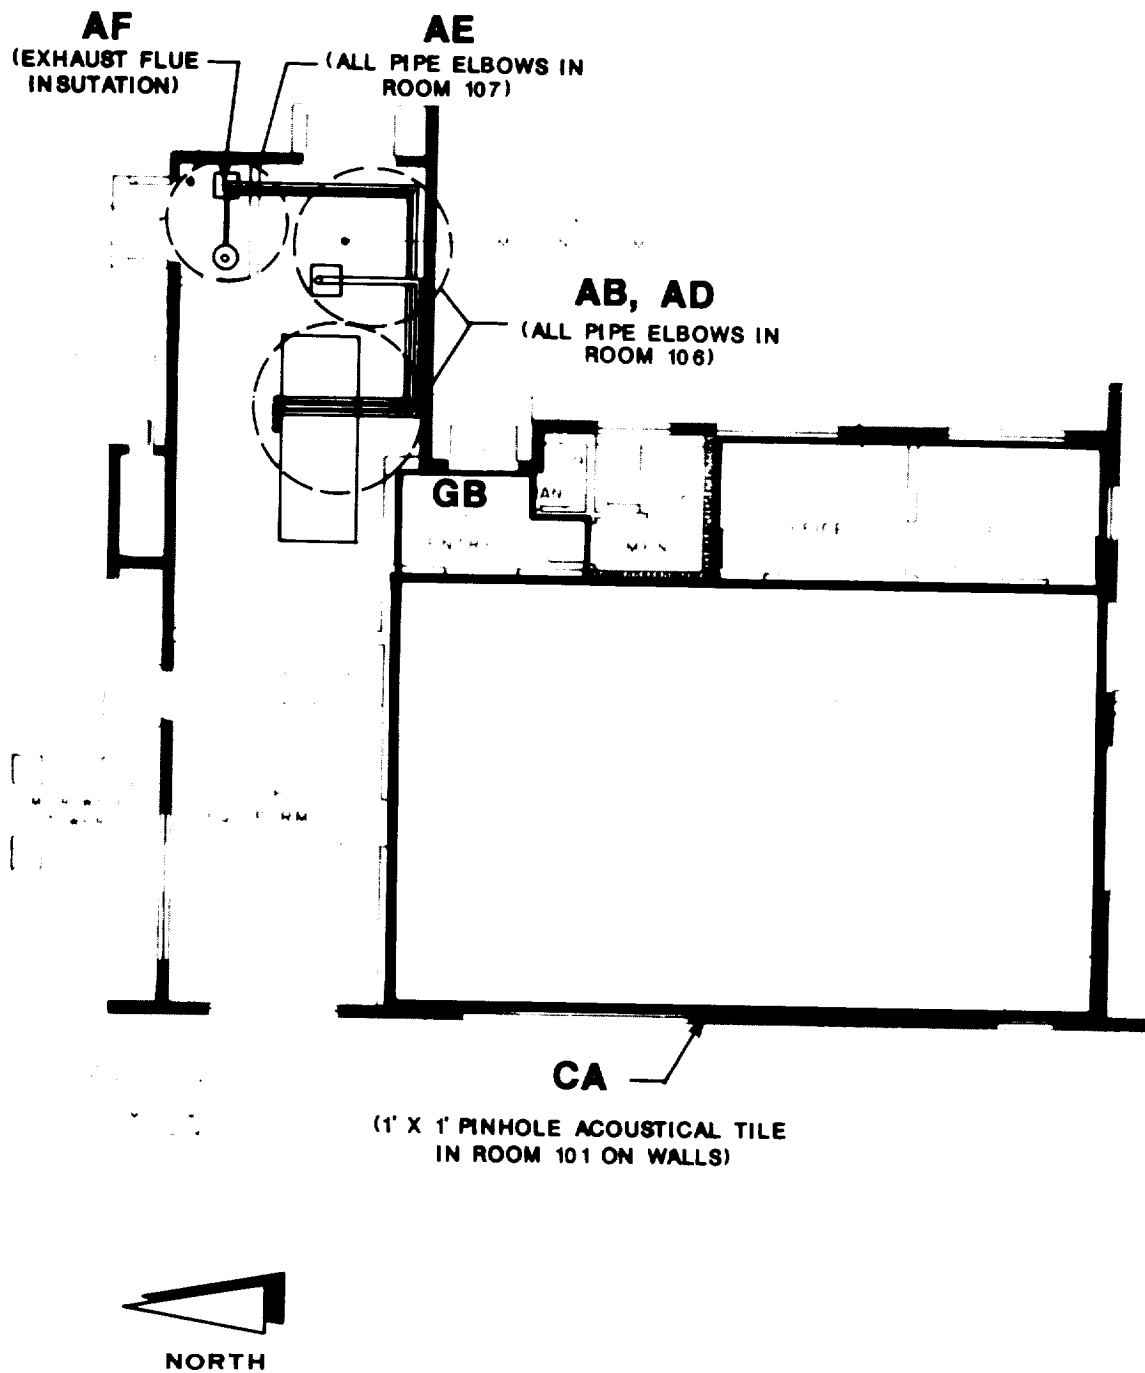
Comments: 9 in. X 2 ft. BEIGE TILE WITH SPECKS. ROOMS 102, 103, AND 105 CONTAIN 9 X 9 in. GREEN TILE WITH WHITE STREAKS LIKE FLOORING IN BUILDING G-56. SEE FIGURE 24.

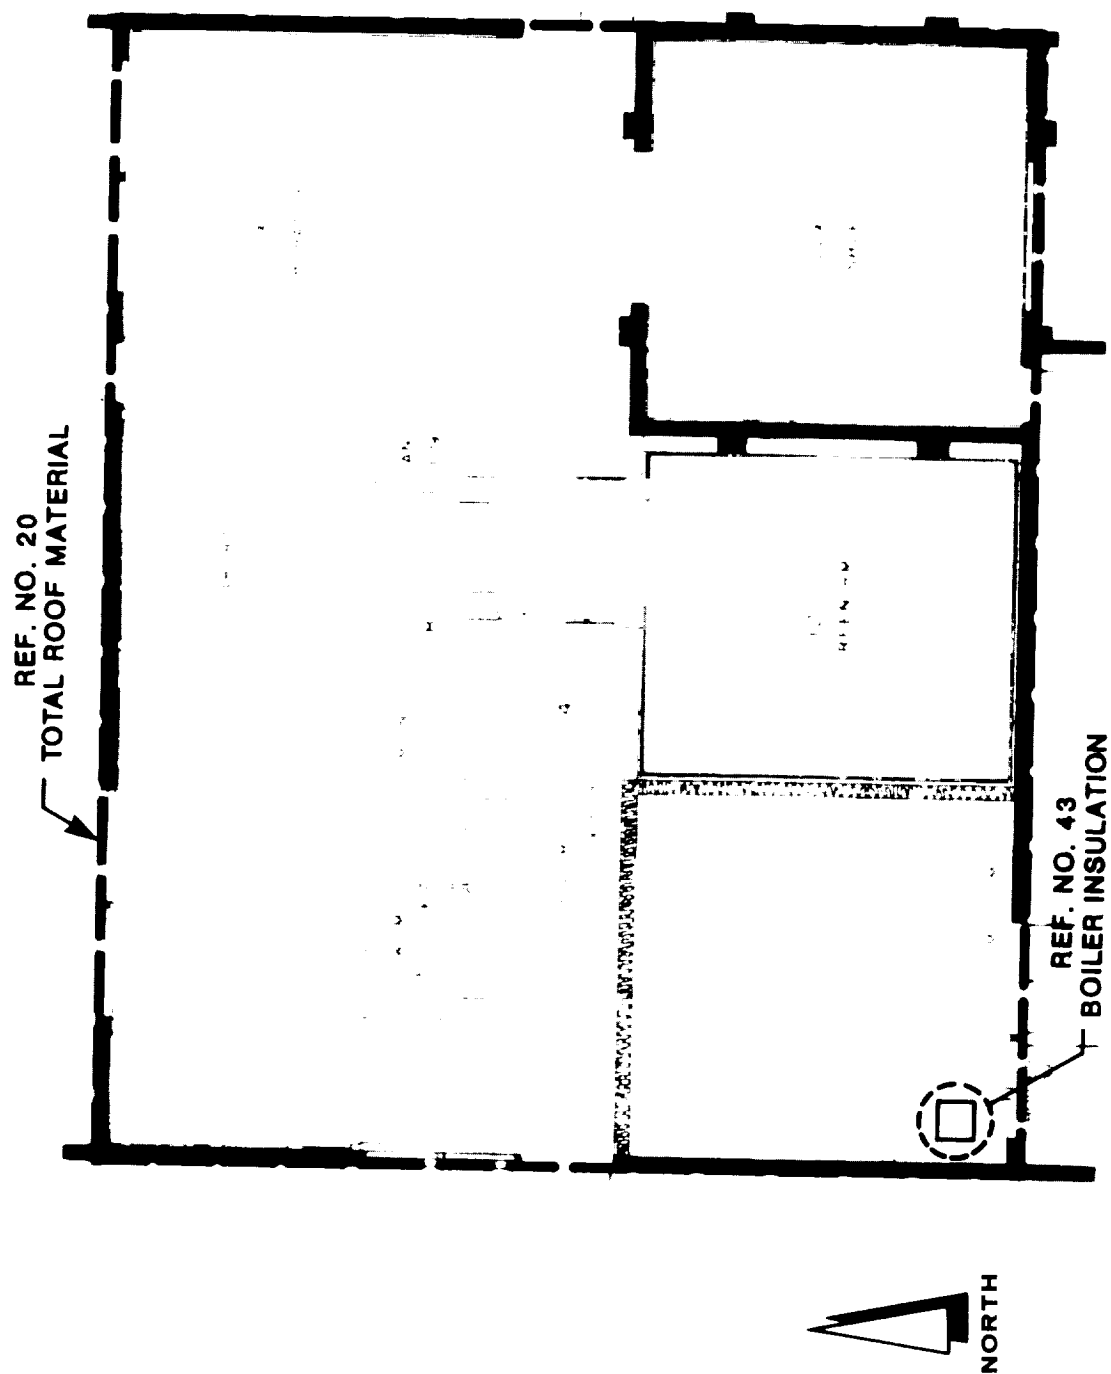
Comments: ROOF MATERIAL COVERED WITH TAR. SEE FIGURE 27.

Figure 27. Microwave Test Facility: Roofing Material of Microwave Test Facility Building G-72.

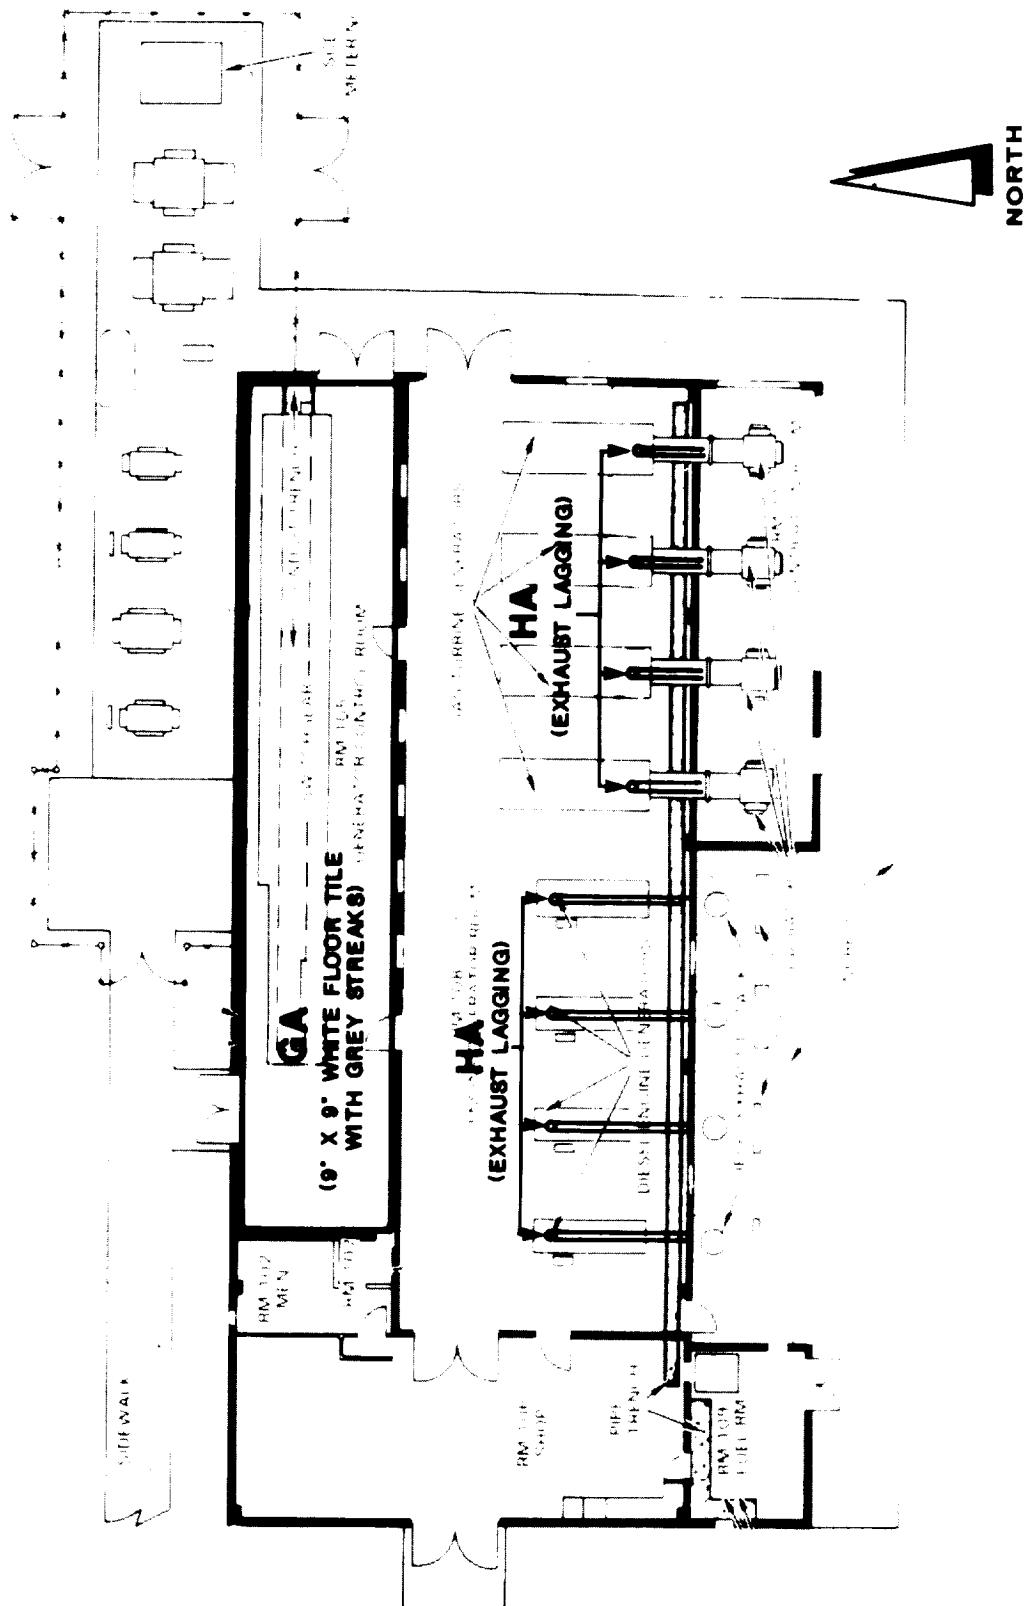
Comments: 9 X 9 in. WHITE TILE WITH GRAY STREAKS. SEE FIGURE 35.

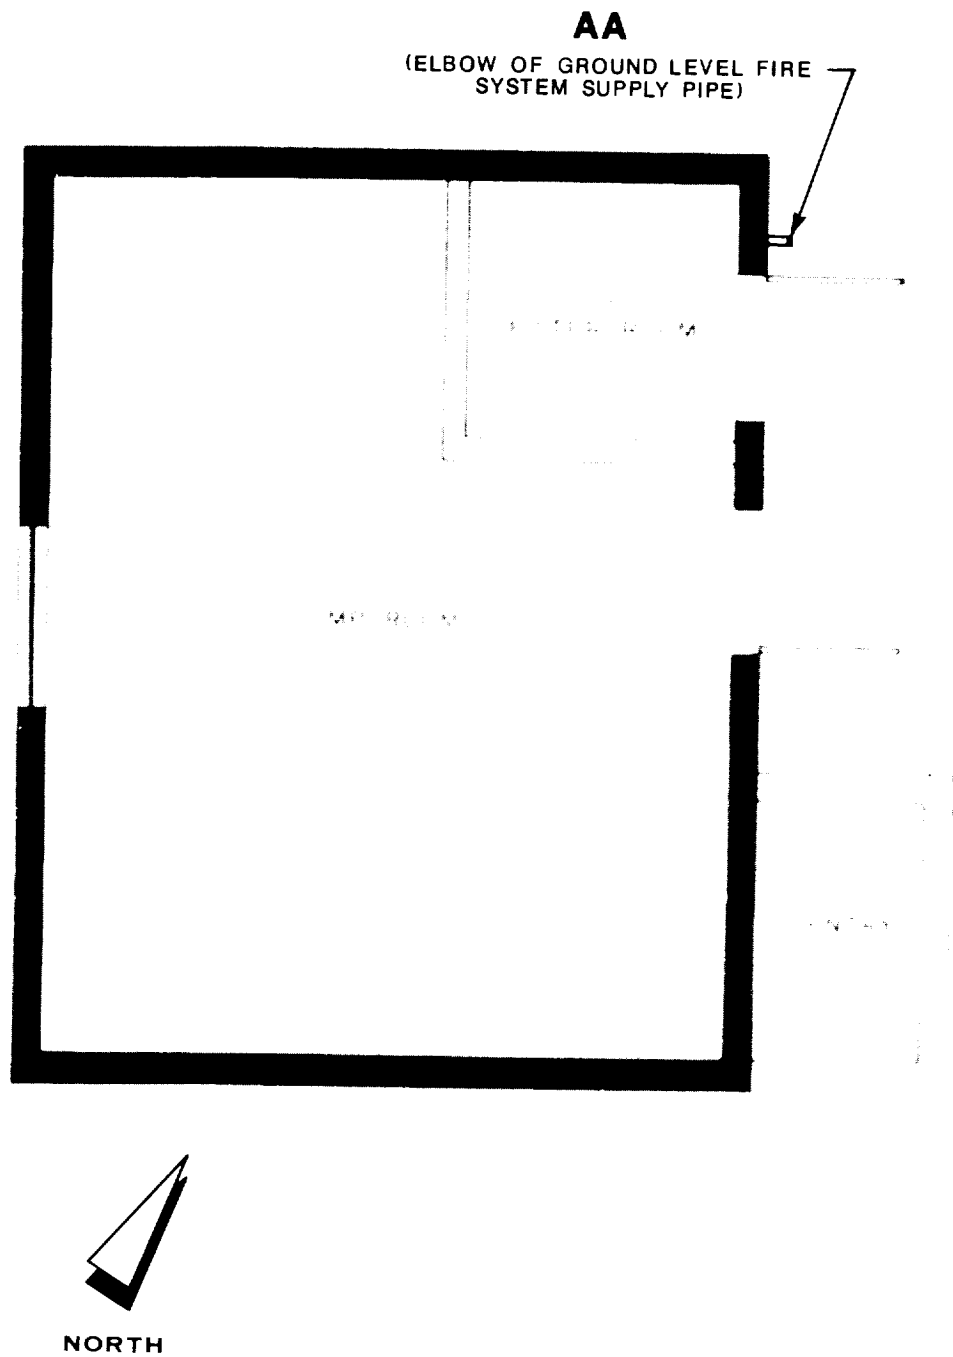
Comments: ELBOW HAS HARD CEMENTITIOUS MATERIAL WITH SOME ADDITIONAL USE EXTENDING AWAY FROM THE ELBOW. SEE FIGURE 36.

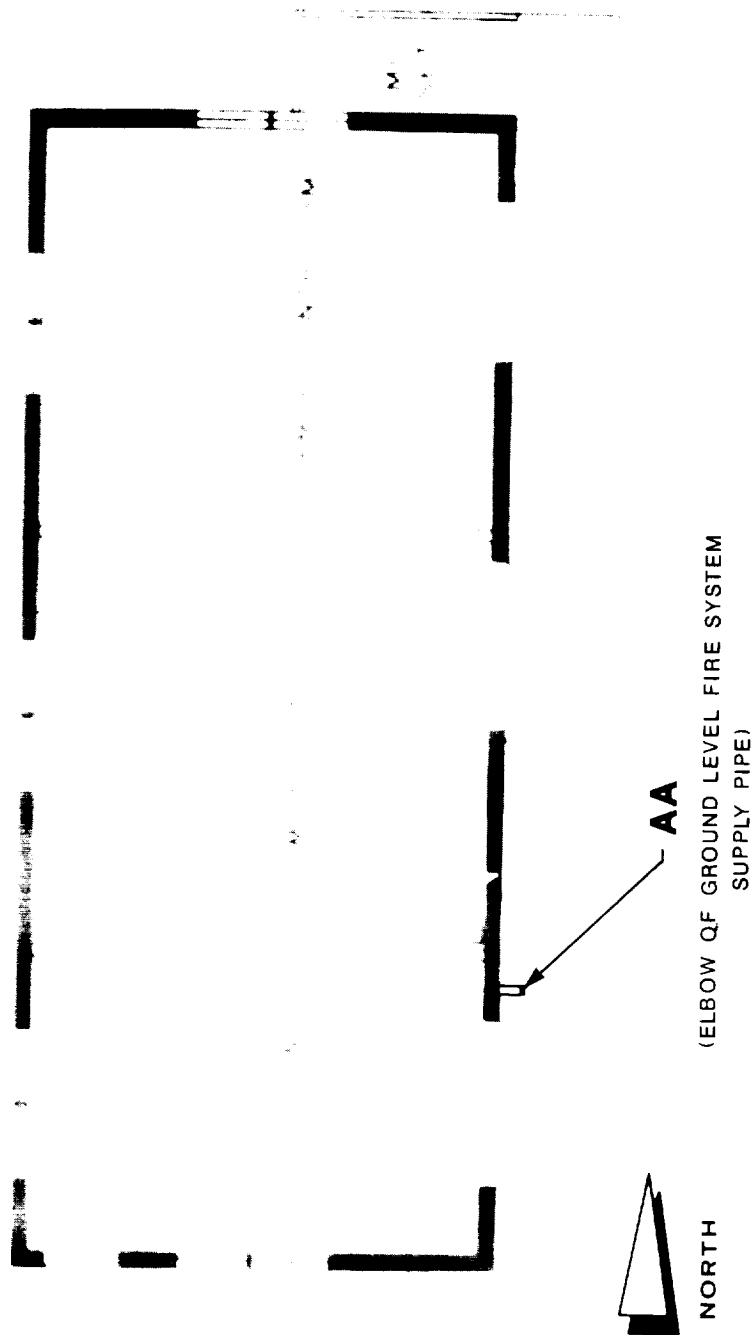
Comments: ELBOW OF HARD CEMENTITIOUS MATERIAL. SEE FIGURE 38.

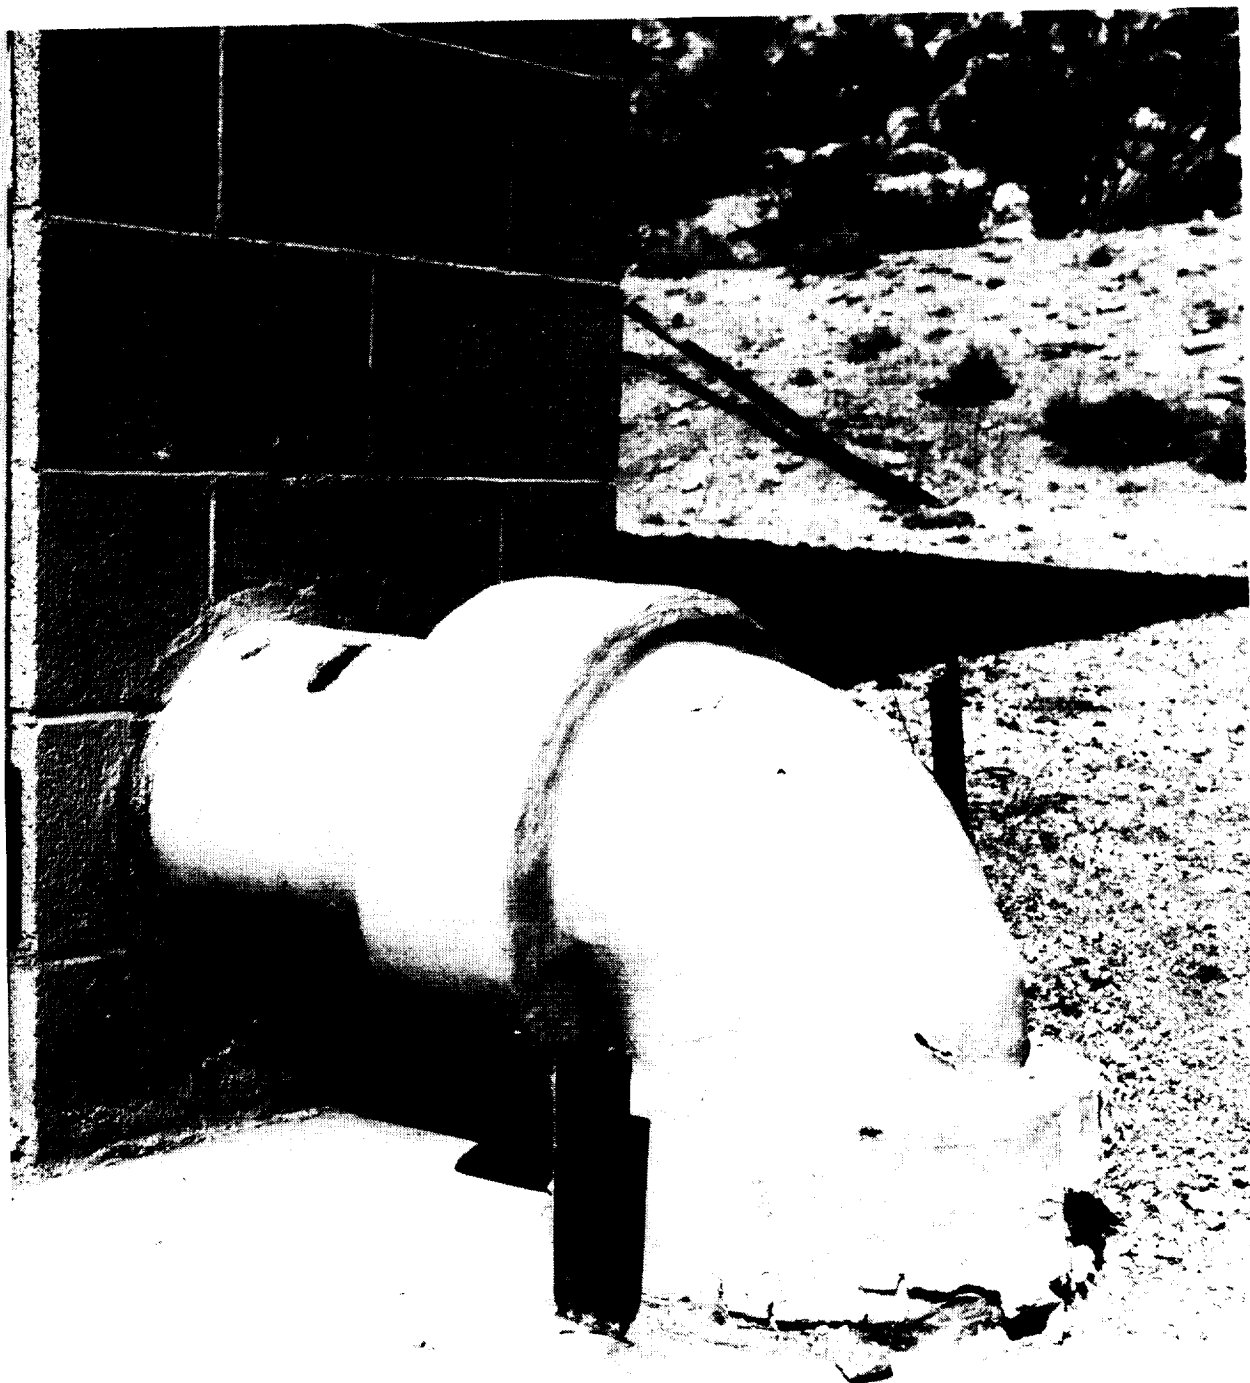
Figure 39. Echo Site: Asbestos-Containing Insulation around Fire System Water Supply Pipe Exterior to Fire Line Pump House G-22. G-22 has Typical Asbestos-Containing Insulation Covering Exterior Pipes that Enter or Leave Buildings G-22, G-27, G-38, G-58 and M-6 at the GDSCC.
